**Flood Control Project Maintenance
Levee Inspections**

Fall 2014 Levee Maintenance Deficiency Summary Report

Sutter Maintenance Yard East Levee Sutter Bypass

Levee Inspection Report By Mile - Fall 2014

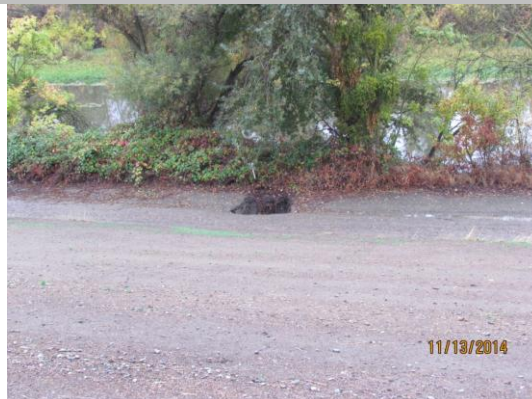
Photo 1 of 1 : FA_2014_ST0002_450_22_20141113_00003.jpg

LM Start	1.60	Rating **	U	Issue No.	22
LM End	1.60	Issue Type +	Ma	Location *	WS
Category	Earthen Levee			GPS Latitude/Longitude	
				Start	End
Item	Erosion / Bank Caving			39.137025 °	39.137025 °
				-121.809713 °	-121.809713 °
DWR ID	DWR_ST0002_01_f_2014_22				
Action/Comments					
Schedule repair of erosion site prior to the next inspection. Inspector Comments: The beaver hole needs to be repaired.

View of the beaver hole at the toe of the levee.

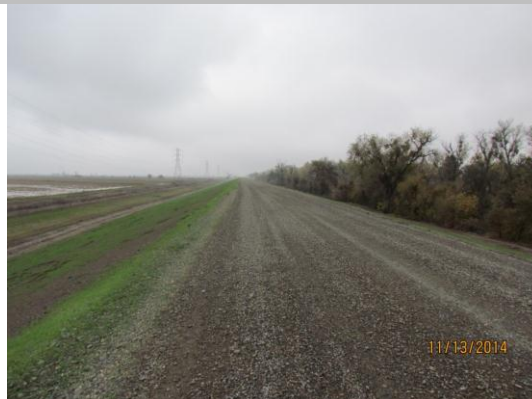
Photo 1 of 1 : FA_2014_ST0002_450_23_20141113_00009.jpg

LM Start	6.22	Rating **	A	Issue No.	23
LM End	6.22	Issue Type +	Ma	Location *	LS
Category	Earthen Levee			GPS Latitude/Longitude	
				Start	End
Item	Vegetation			39.090835 °	39.090835 °
				-121.752755 °	-121.752755 °
DWR ID	DWR_ST0002_01_f_2014_23				
Action/Comments					
Control annual grass and weeds on the levee slopes and easements.

View of no vegetation on both slopes.

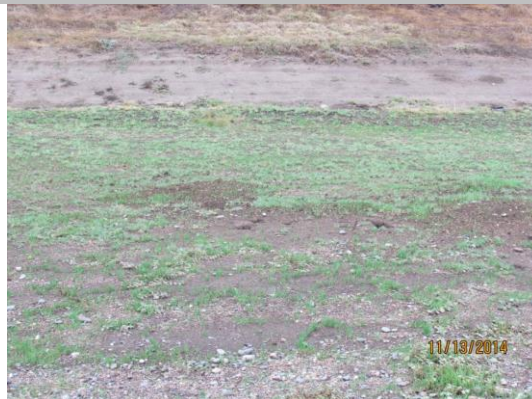
Photo 1 of 1 : FA_2014_ST0002_450_24_20141113_00007.jpg

LM Start	16.44	Rating **	M	Issue No.	24
LM End	16.44	Issue Type +	Ma	Location *	LS
Category	Earthen Levee			GPS Latitude/Longitude	
				Start	End
Item	Animal Control			38.965188 °	38.965188 °
				-121.670365 °	-121.670365 °
DWR ID	DWR_ST0002_01_f_2014_24				
Action/Comments					
No rodents visible, but rodent burrows visible; need to backfill and compact or grout burrows.

View of the rodent holes on the landside slope.

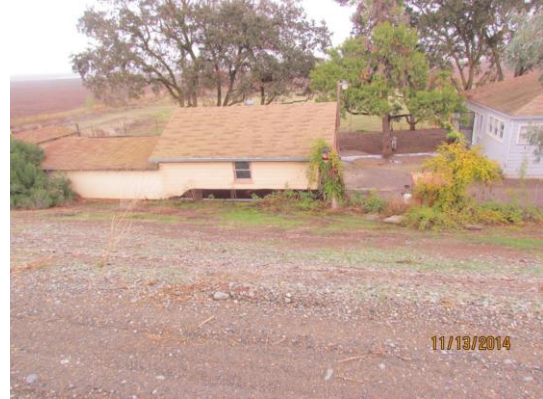
Photo 1 of 1 : FA_2014_ST0002_450_10_20141113_00008.jpg

LM Start	20.64	Rating **	U	Issue No.	10
LM End	20.64	Issue Type +	En	Location *	LS
Category	Earthen Levee			GPS Latitude/Longitude	
				Start	End
Item	Encroachments			38.918147 °	38.918147 °
				-121.624545 °	-121.624545 °
DWR ID	DWR_ST0002_01_s_ 2012_10				
Action/Comments					
Building

View of the house next to the toe of the levee.
